## Potential Safety Hazard for Hobart Mixer: Inspect Bowl Guard Hardware Immediately

**Topic:** Model HL200 Hobart Mixers may have loose hardware (screws/nuts) on bowl guard.

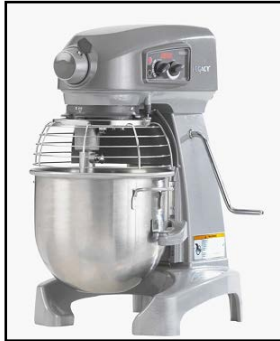
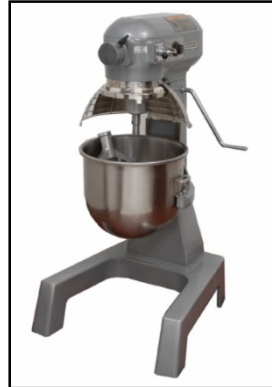
- To prevent screws/nuts from falling into product that could be served to customer, inspect Hobart HL200 mixer (countertop model AND free-standing, floor model) immediately for loose parts on bowl guard.

**Solution:** Perform safety inspection, checking screws/nuts on bowl guard. Contact Hobart for replacement bowl guard if hardware is loose.

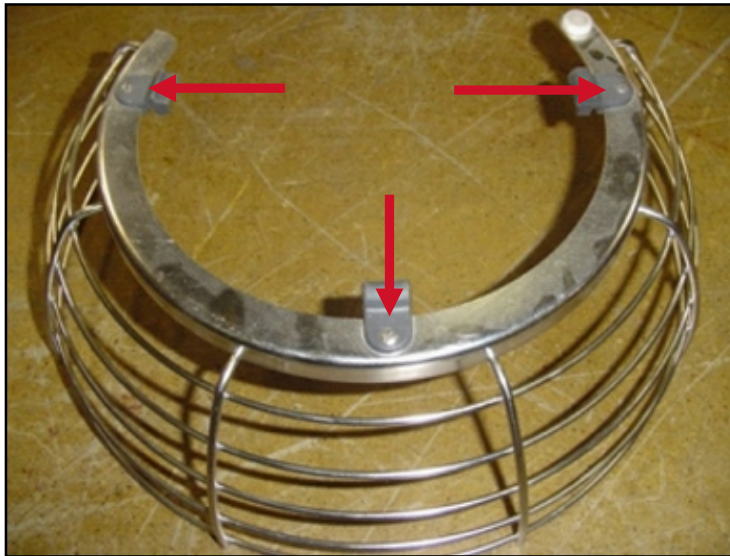
### Bowl Guard:

Check 3 bowl guard screws (top side) and 3 nuts (bottom side).

- If any loose bowl guard items are detected, contact **Mary Fritz** at Hobart Corporation Customer Service at [937-332-2497](tel:937-332-2497) or [mary.fritz@hobartcorp.com](mailto:mary.fritz@hobartcorp.com).
  - ❑ Operator must provide mixer serial #, shipping address and contact phone number.
  - ❑ Hobart will ship Restaurant a new replacement bowl guard overnight **at no charge**.
